# Your Inspection Report

[REDACTED]  
Tallahassee, FL 32303

Monday, April 29, 2024

RE: Report No. 3105

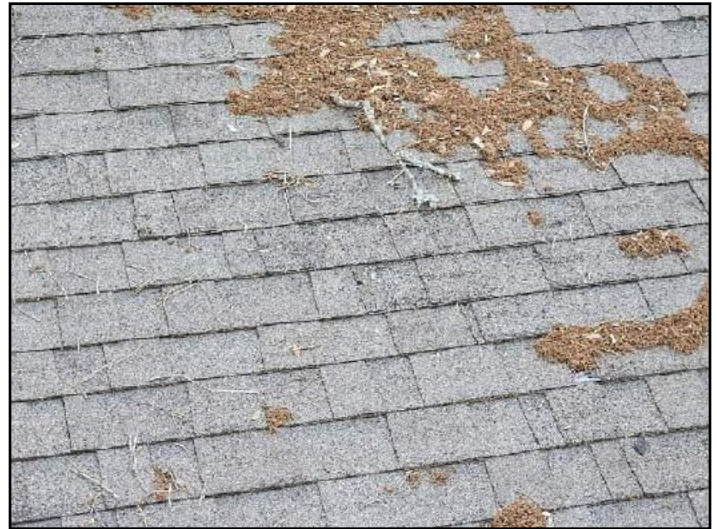
**Condition:** • Granule loss is an indication of roof shingle wear. Excessive amounts can be an indication of nearing the end of useful life expectancy and may be an obstacle in obtaining homeowners insurance

**Implication(s):** Chance of water damage to structure, finishes and contents

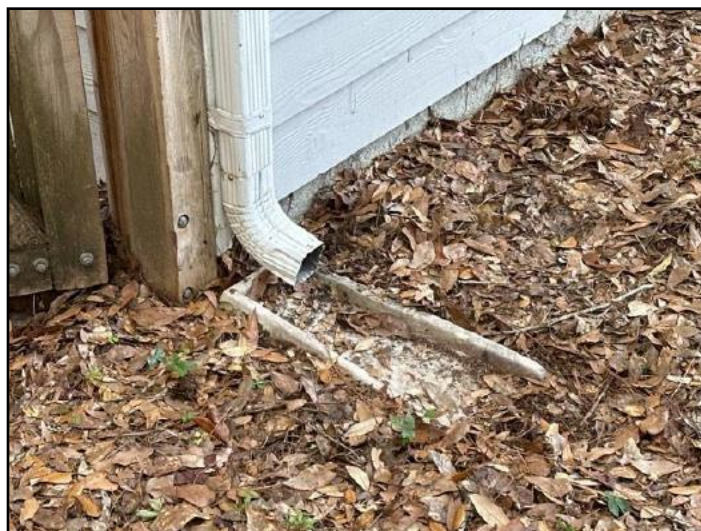
5. Gutter discharge 4-6 feet from building or...

**Condition:** • Gutter discharge 4-6 feet from building or foundation can greatly reduce the chance of water collection at the foundation and opportunities for settlement

Gutter downspout extensions can greatly reduce water collection and intrusion into the Crawlspace which can reduce mold and mildew growth. For foundation structures; can reduce the likelihood of soil erosion at the foundation and settlement cracks

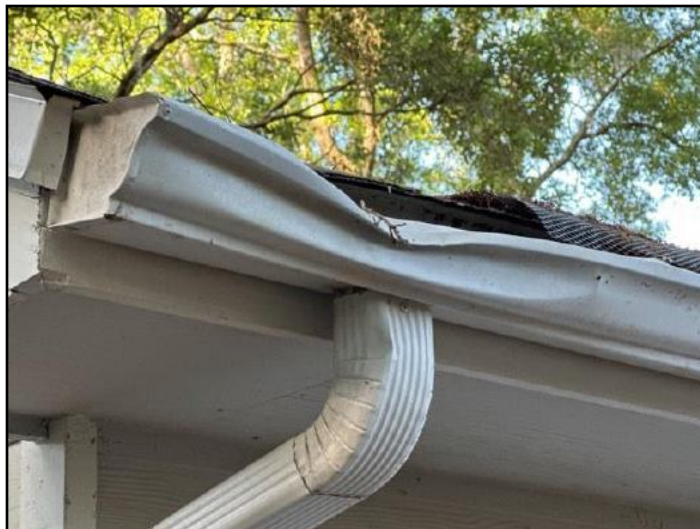
6. Damage

**Condition:** • Damage

**Task:** Gutter Contractor - Repair or replace

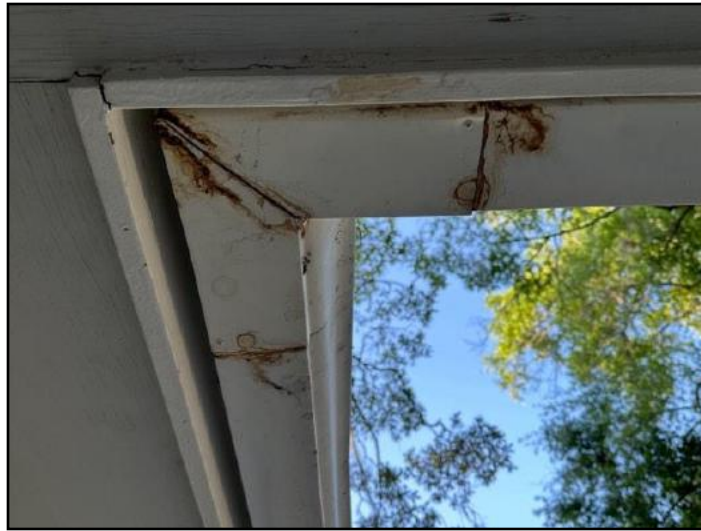
7. Leak

**Condition:** • [Leak](#)

**Implication(s):** Chance of water damage to structure, finishes and contents

**Task:** Gutter contractor - repair/replace

**Time:** As soon as practical

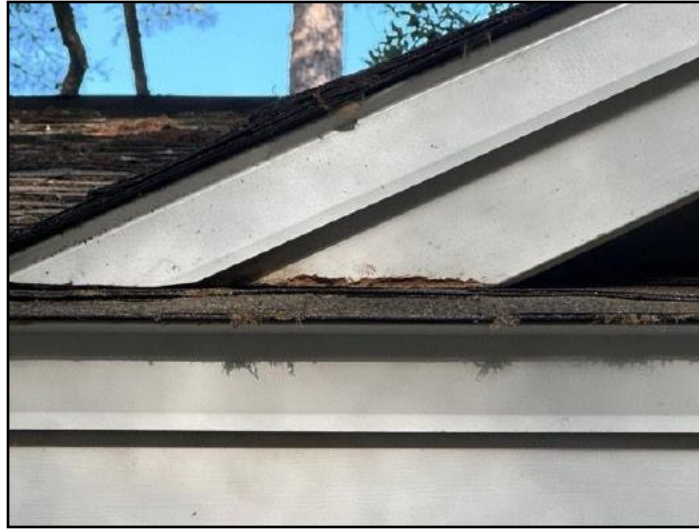
8. Observed wood rot or Detected above normal...

**Condition:** • Observed wood rot or Detected above normal levels of moisture with damage to wood material or noted damage/wood rot/insect damage noted in various locations, Recommend repairing or replacing water moisture damage or wood rot sections to prevent further water intrusion.

**Implication(s):** Chance of water damage to structure, finishes and contents | Material deterioration

**Task:** Handyman Skill Level - Repair or replace as required

**Time:** As soon as practical - To prevent water intrusion

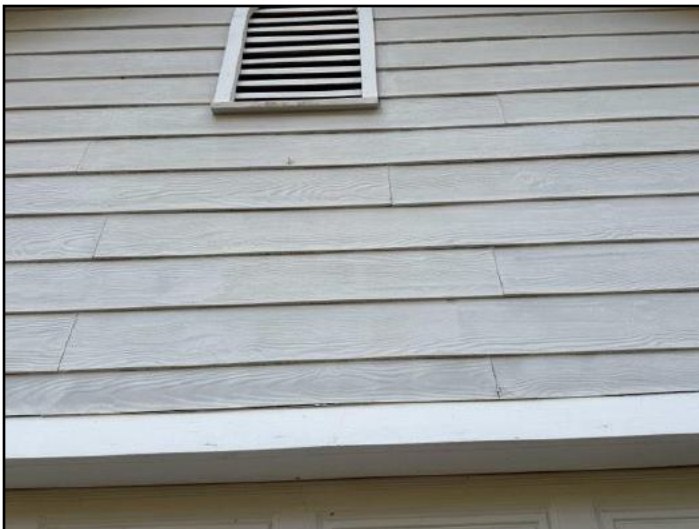
9. Marginal

**Condition:** • Marginal

Recommend caulking at all seams and penetrations around doors and windows to prevent water intrusion

**Task:** DIY Skill Level - Handyman Skill Level - Repair Protect

**Time:** As soon as practical - To prevent water intrusion

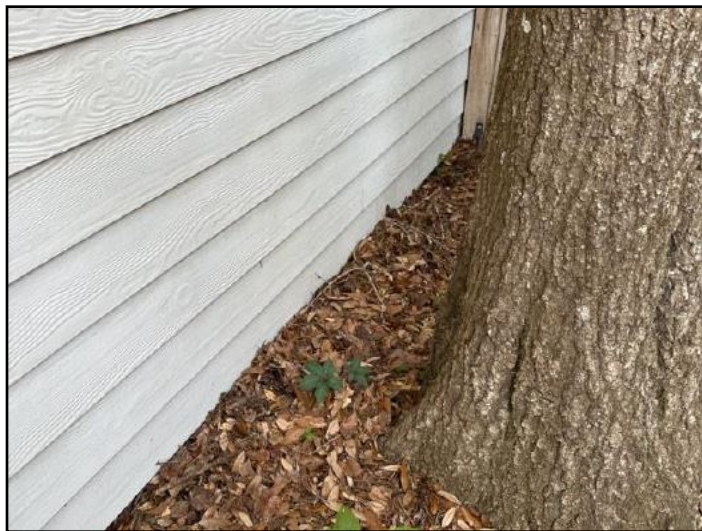
18. Too close to grade

**Condition:** • [Too close to grade](#)

**Implication(s):** Chance of water damage to structure, finishes and contents | Material deterioration | Rot | Insect damage

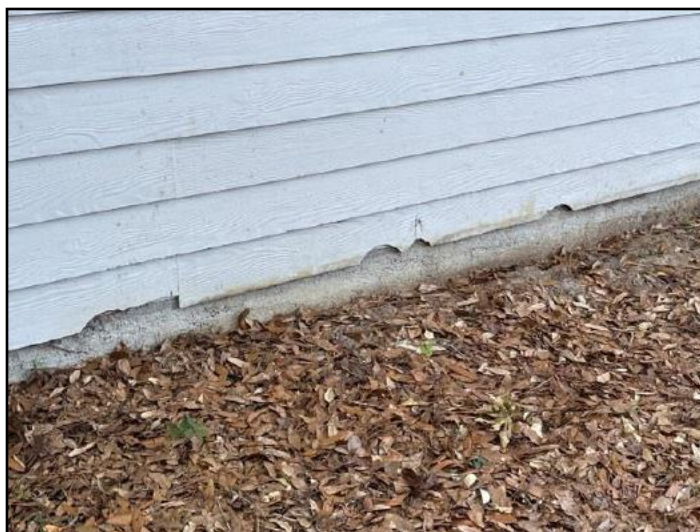
19. Cracked, split or broken

**Condition:** • [Cracked, split or broken](#)

**Implication(s):** Chance of water damage to structure, finishes and contents

**Task:** Handyman Skill Level - Repair

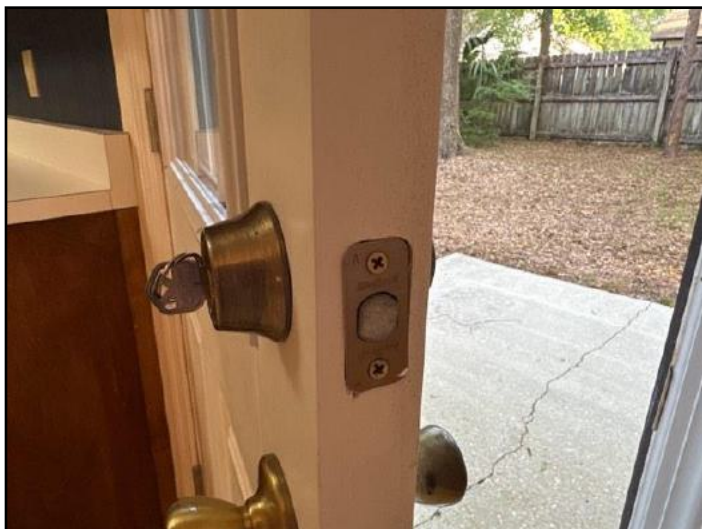
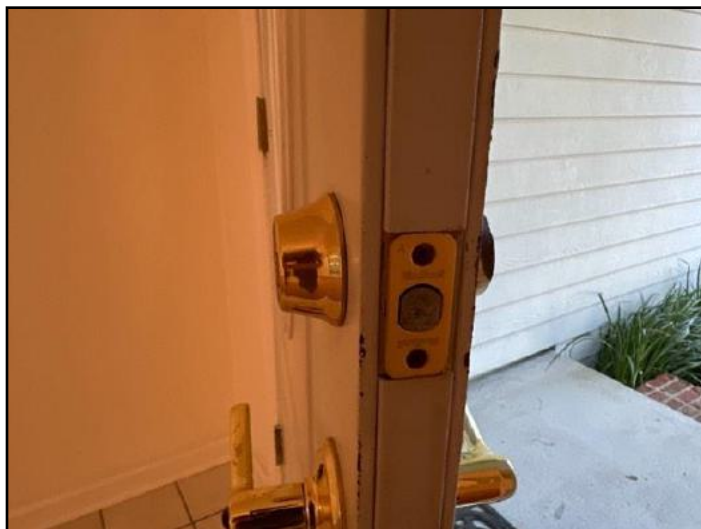
**Condition:** • Double Key Deadbolt noted. This can create a safety or fire egress concern.

20. Double Key Deadbolt noted. This can create...

**Implication(s):** Recommend replacing deadbolt with a single key deadbolt

**Task:** Handyman Skill Level - Replace

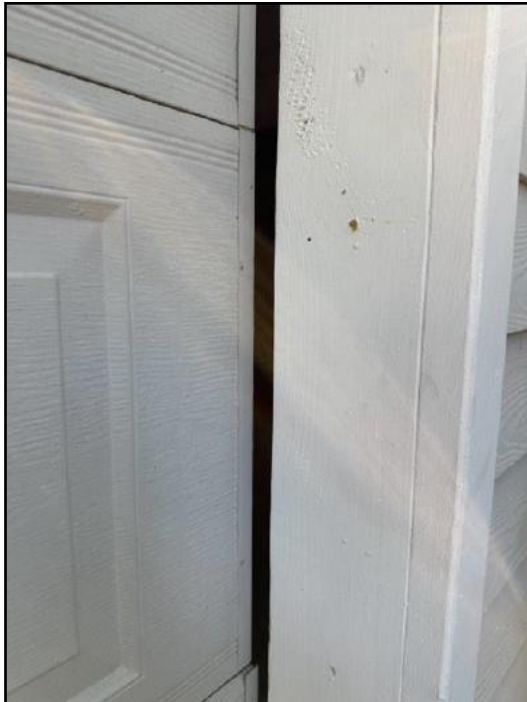
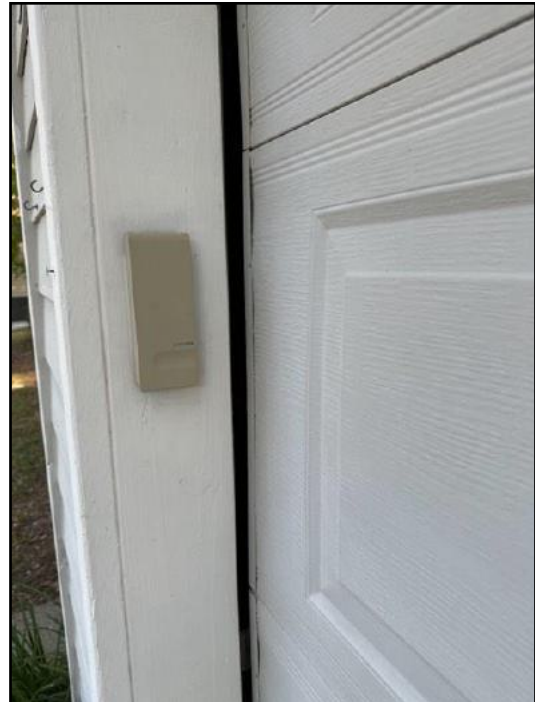
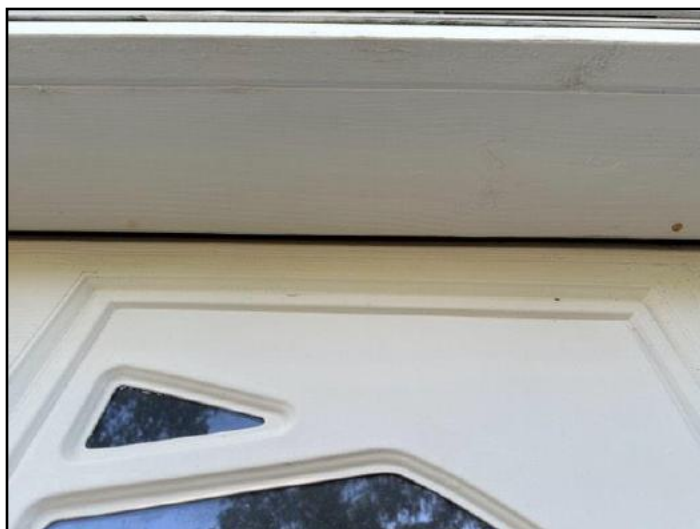
**Condition:** • Weatherstripping damaged or missing.

23. Weatherstripping damaged or missing.

**Task:** Handyman Skill Level - Install/Correct

**Time:** As soon as practical

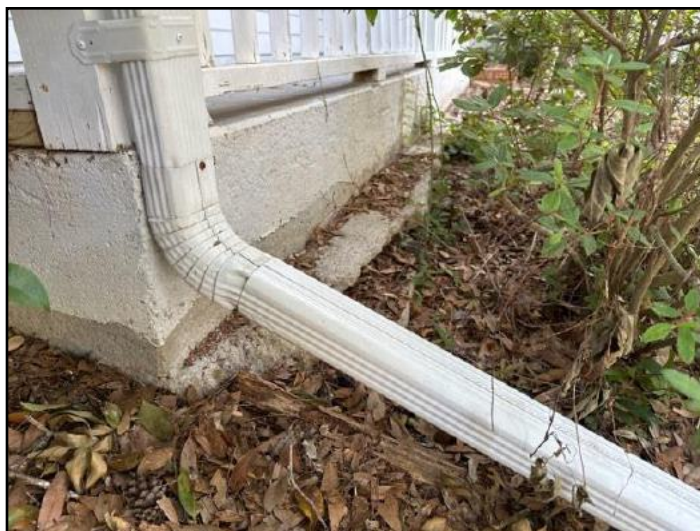
26. Soil erosion noted. This condition can...

**Condition:** • Soil erosion noted. This condition can create opportunities for settlement. Recommend adding additional backfill and soil compaction. Gutter & downspout with extensions or water diverting landscaping techniques can prevent reoccurrence

**Task:** Landscape Professional - Repair Improve Protect

**Time:** As soon as practical - To prevent further deterioration

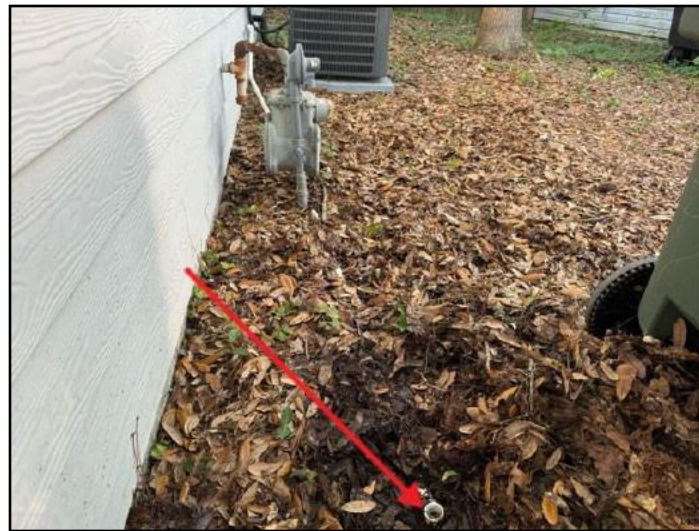
30. Blocked or crimped

**Condition:** • Blocked or crimped

**Implication(s):** Chance of water damage to structure, finishes and contents | Damage to equipment

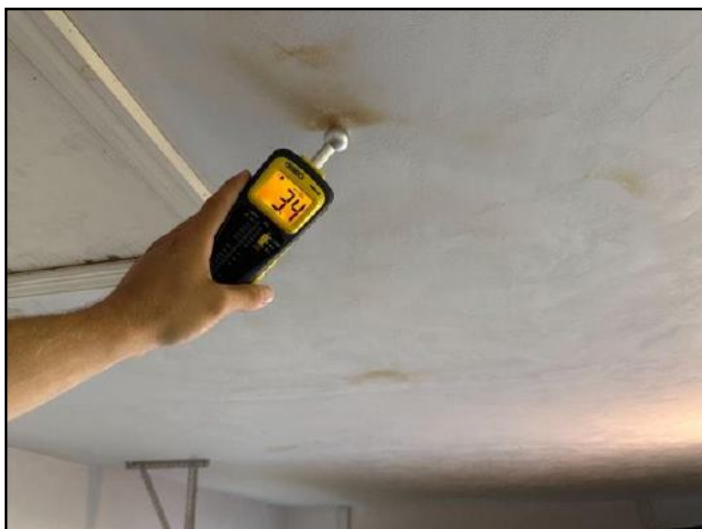
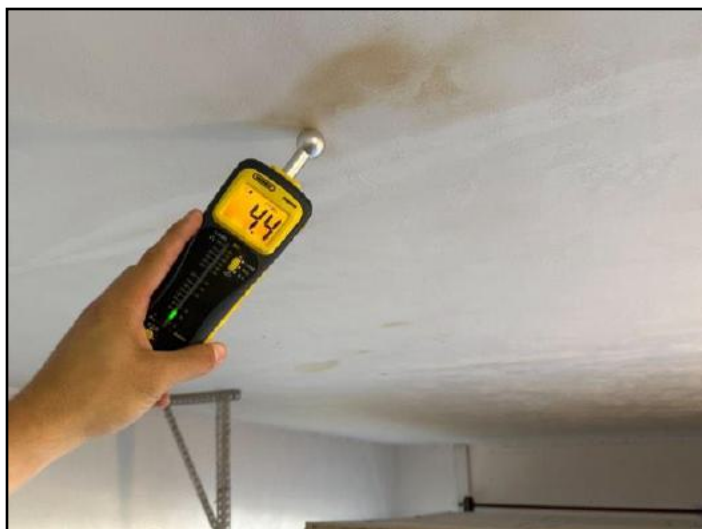
**Condition:** • Stains on ceiling. NO moisture detected. Possible prior water leak. Recommend to Prime and paint to remove stains

**Implication(s):** Chance of water damage to structure, finishes and contents

35. Stains on ceiling. NO moisture detected...

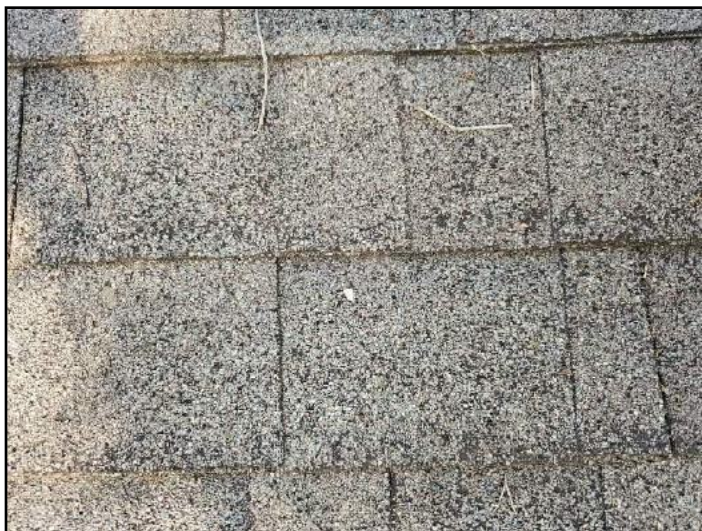
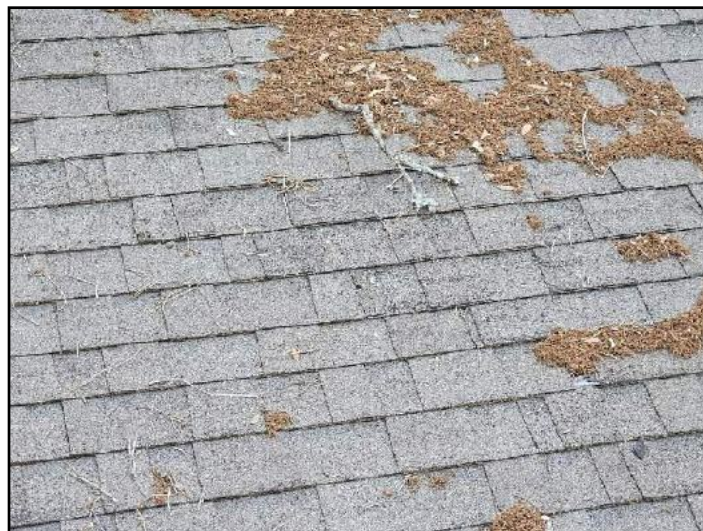
**4. Condition:** • Granule loss is an indication of roof shingle wear. Excessive amounts can be an indication of nearing the end of useful life expectancy and may be an obstacle in obtaining homeowners insurance

**Implication(s):** Chance of water damage to structure, finishes and contents

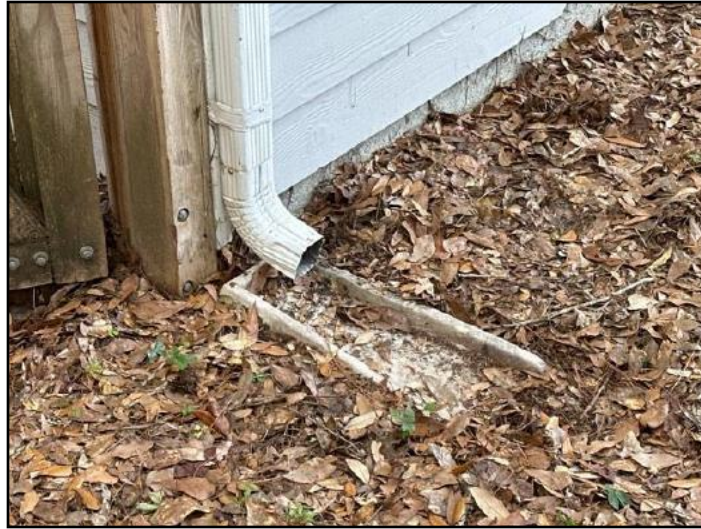
62. Gutter discharge 4-6 feet from building or...

**9. Condition:** • Gutter discharge 4-6 feet from building or foundation can greatly reduce the chance of water collection at the foundation and opportunities for settlement

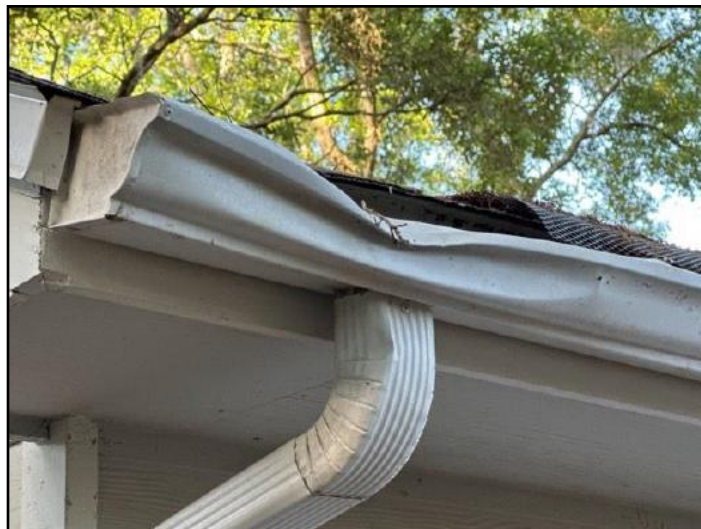
63. Damage

**10. Condition:** • Damage

**Task:** Gutter Contractor - Repair or replace

**Time:** As soon as practical

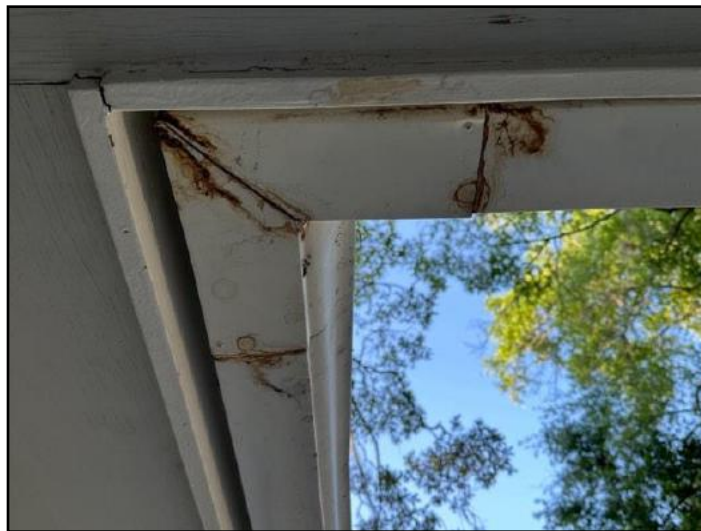
64. Leak

**11. Condition:** • [Leak](#)

**Time:** As soon as practical

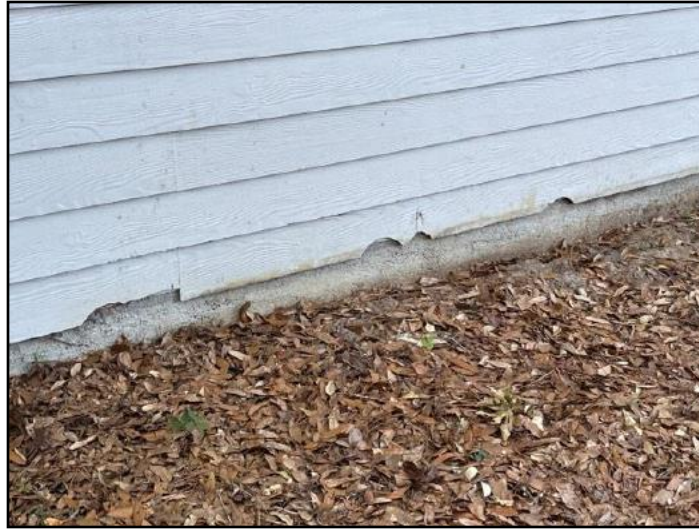
76. Cracked, split or broken

**16. Condition:** • [Cracked, split or broken](#)

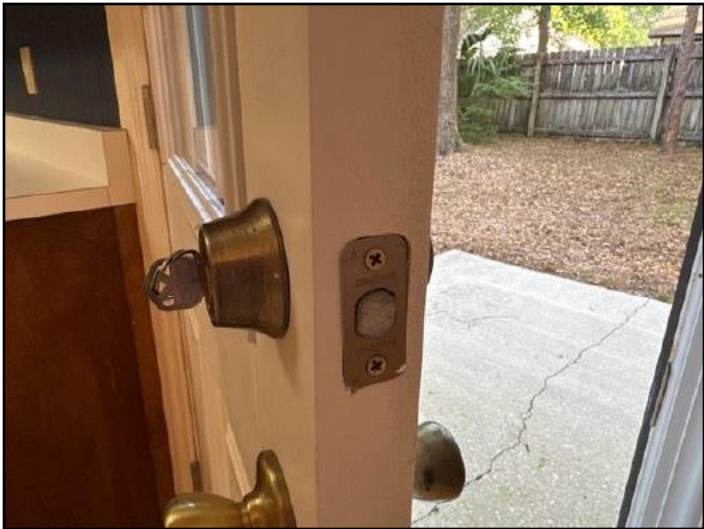
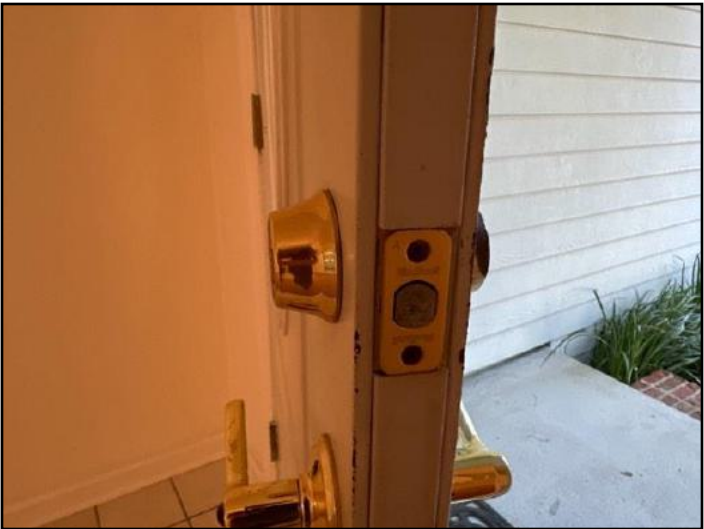
77. Double Key Deadbolt noted. This can create...

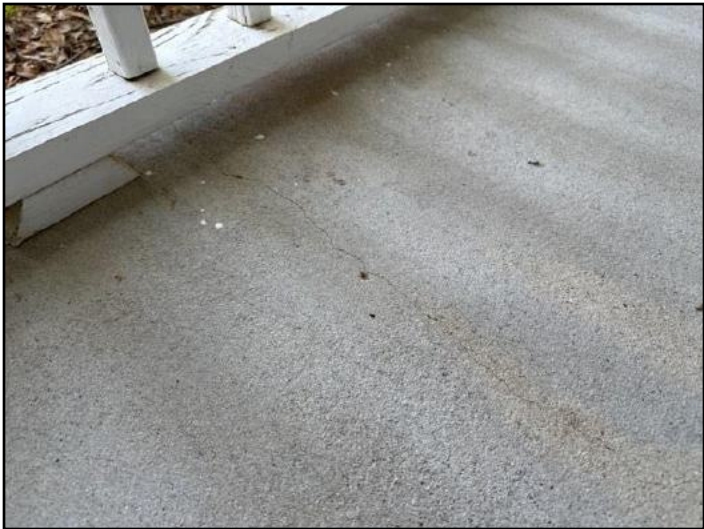
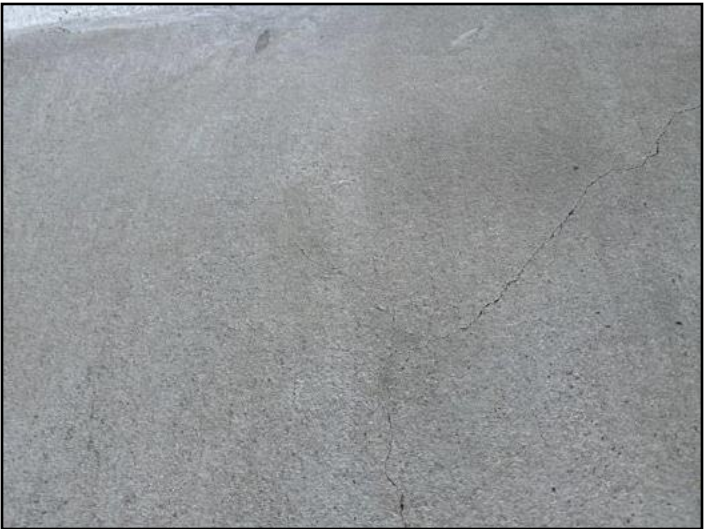
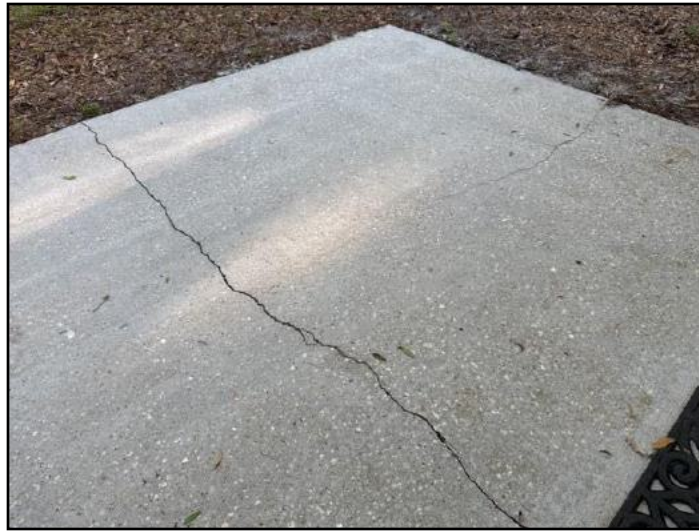
79. Patio/porch had some typical cracks and is...

**Task:** Seal & Monitor

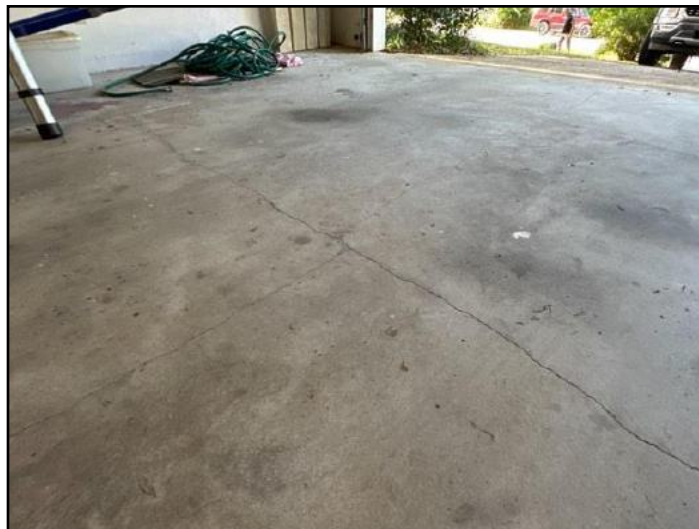
**84.** *Garage floor has typical cracks but appears...*

**Task:** Handyman Skill Level - Seal & Monitor

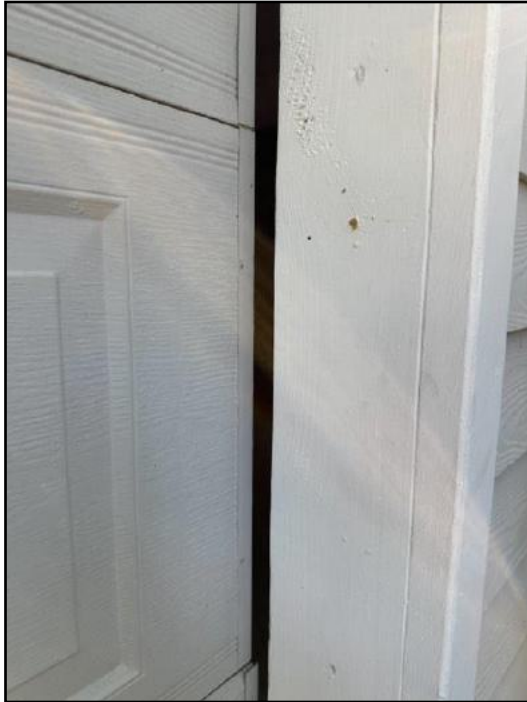
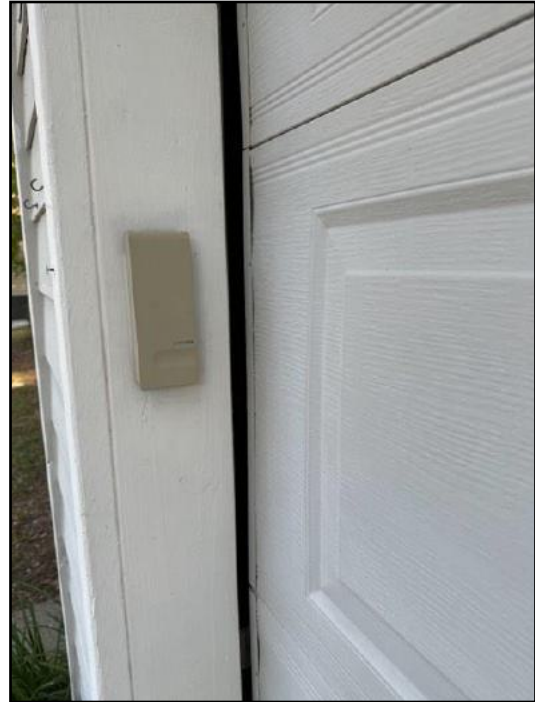
85. Weatherstripping damaged or missing.

**Task:** Handyman Skill Level - Install/Correct

**Time:** As soon as practical

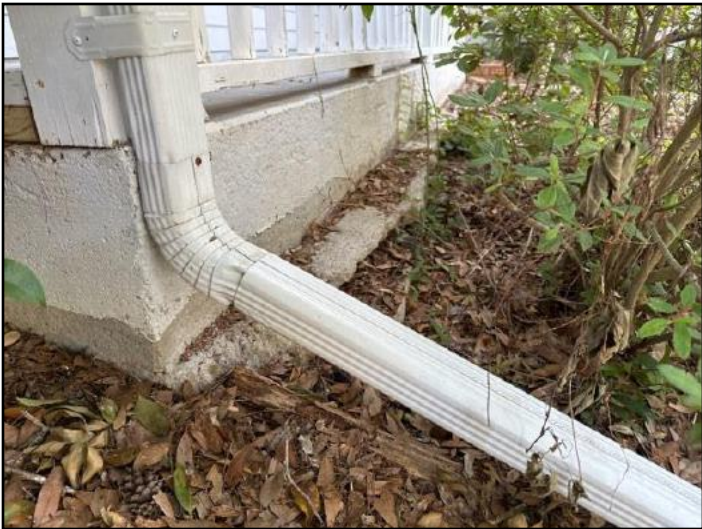
90. Soil erosion noted. This condition can...

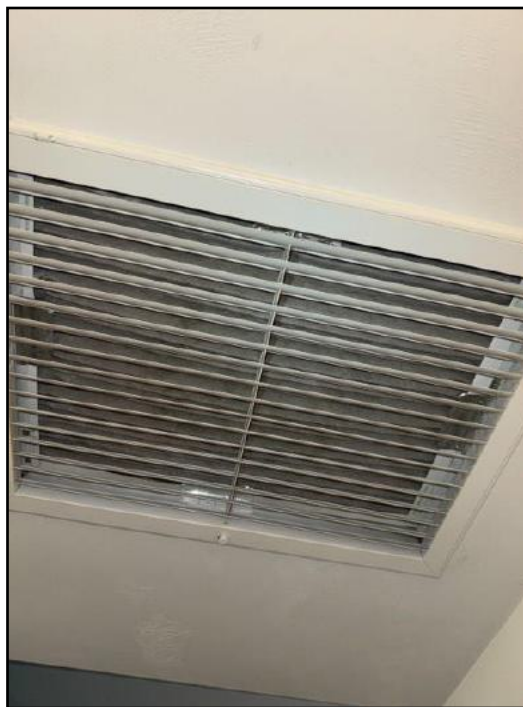
**109.** *Dirty or clogged. Recommend changing filters*

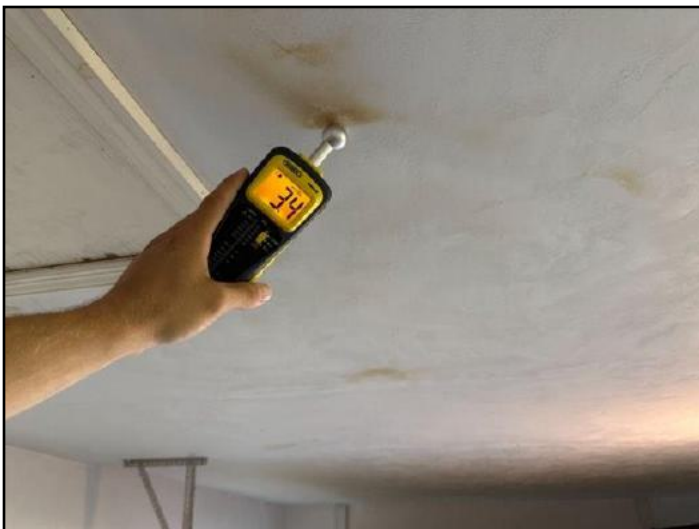
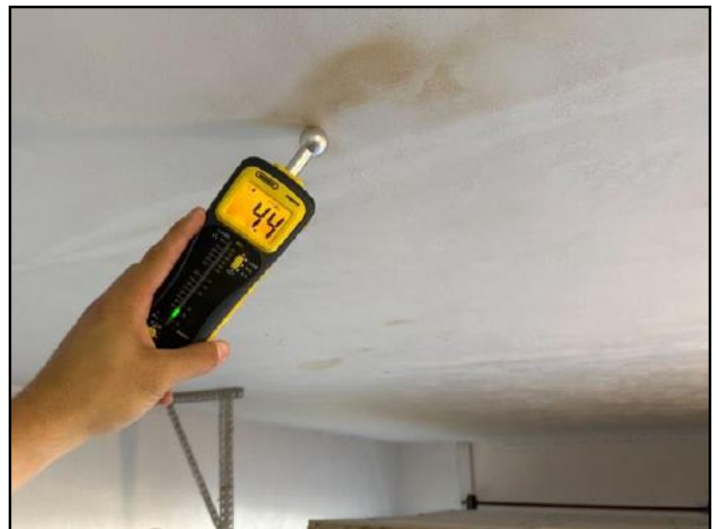
162. Stains on ceiling. NO moisture detected...

**Task:** Monitor
