# Your Inspection Report

[REDACTED]  
Tallahassee, FL 32303

Monday, April 29, 2024

RE: Report No. 3105

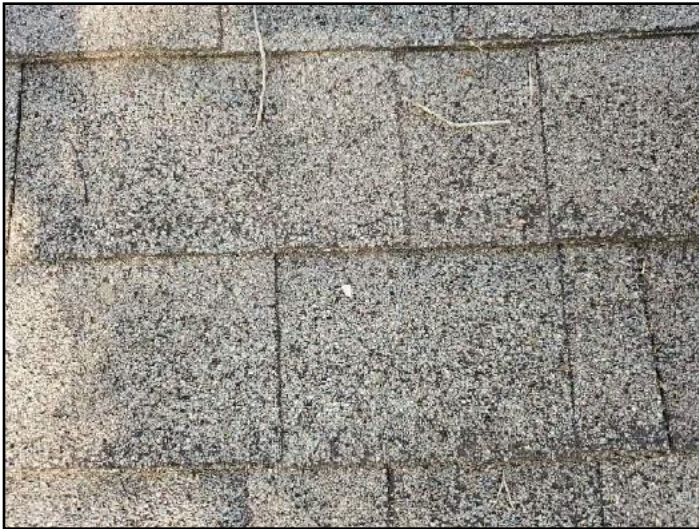
**Condition:** • Granule loss is an indication of roof shingle wear. Excessive amounts can be an indication of nearing the end of useful life expectancy and may be an obstacle in obtaining homeowners insurance

**Implication(s):** Chance of water damage to structure, finishes and contents

1. Granule loss is an indication of roof...

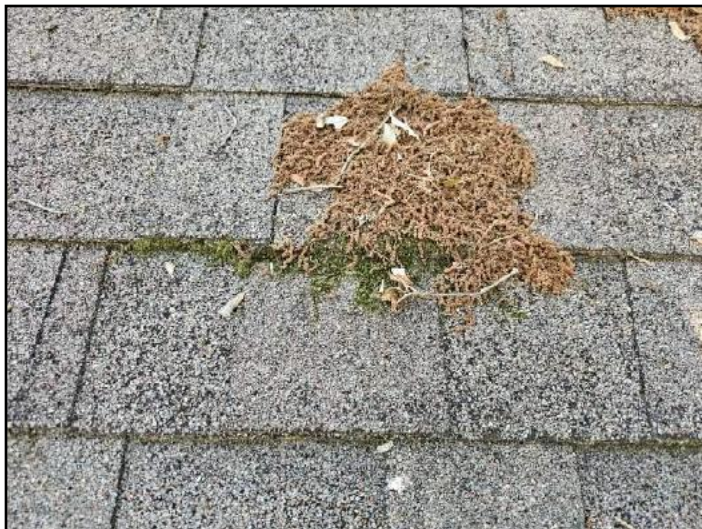
**Condition:** • Debris/moss

3. Debris/moss

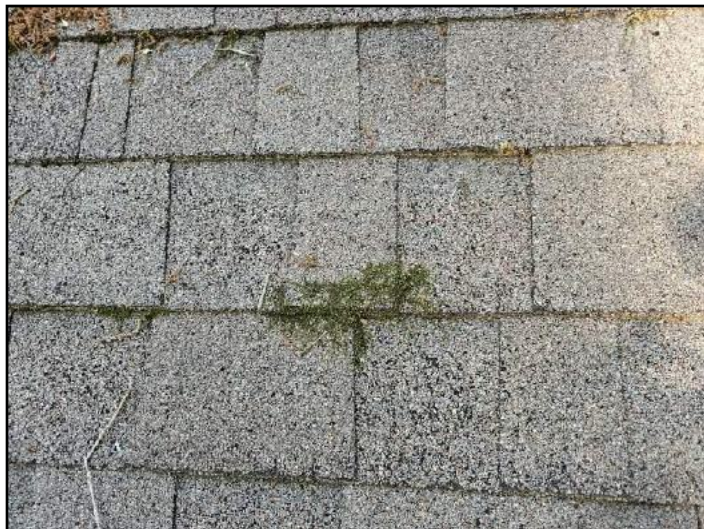
4. Debris/moss

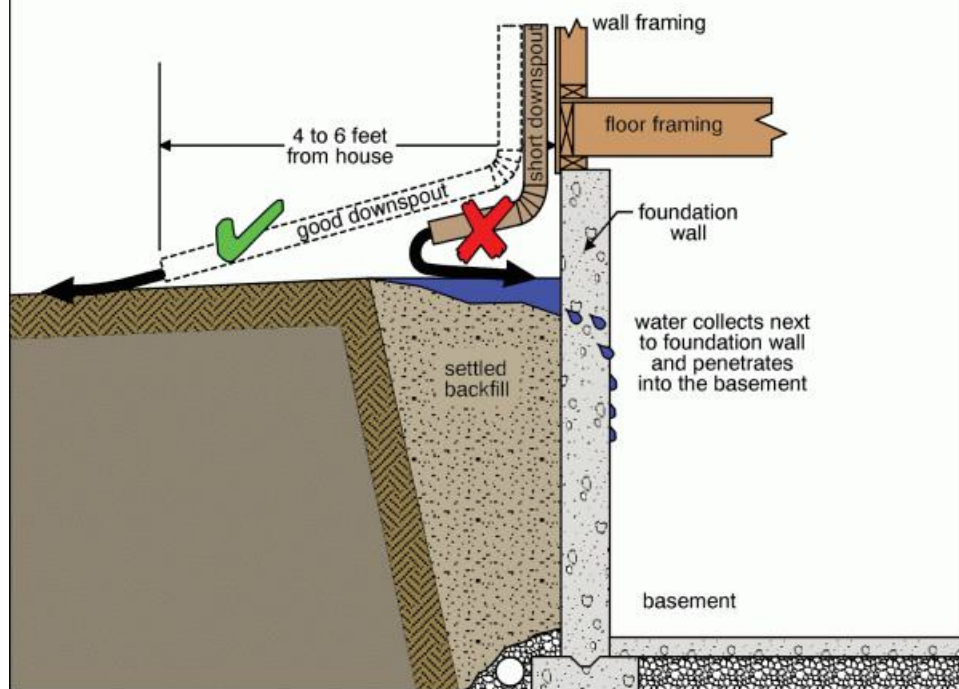
**Condition:** • Gutter discharge 4-6 feet from building or foundation can greatly reduce the chance of water collection at the foundation and opportunities for settlement

Gutter downspout extensions can greatly reduce water collection and intrusion into the Crawlspace which can reduce mold and mildew growth. For foundation structures; can reduce the likelihood of soil erosion at the foundation and settlement cracks

5. Gutter discharge 4-6 feet from building or...

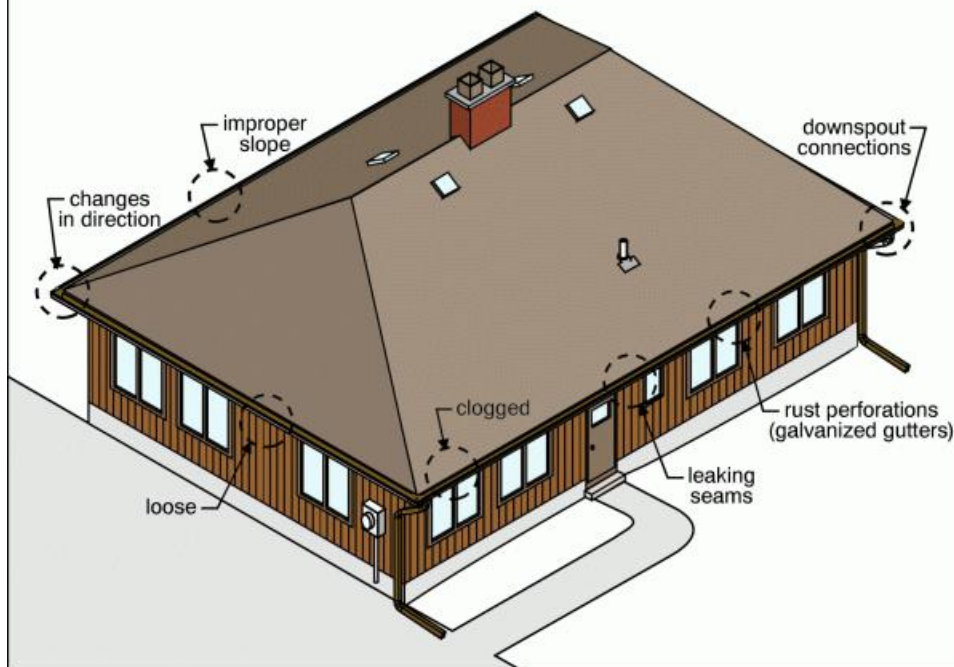
**Condition:** • [Leak](#)

**Implication(s):** Chance of water damage to structure, finishes and contents

**Task:** Gutter contractor - repair/replace

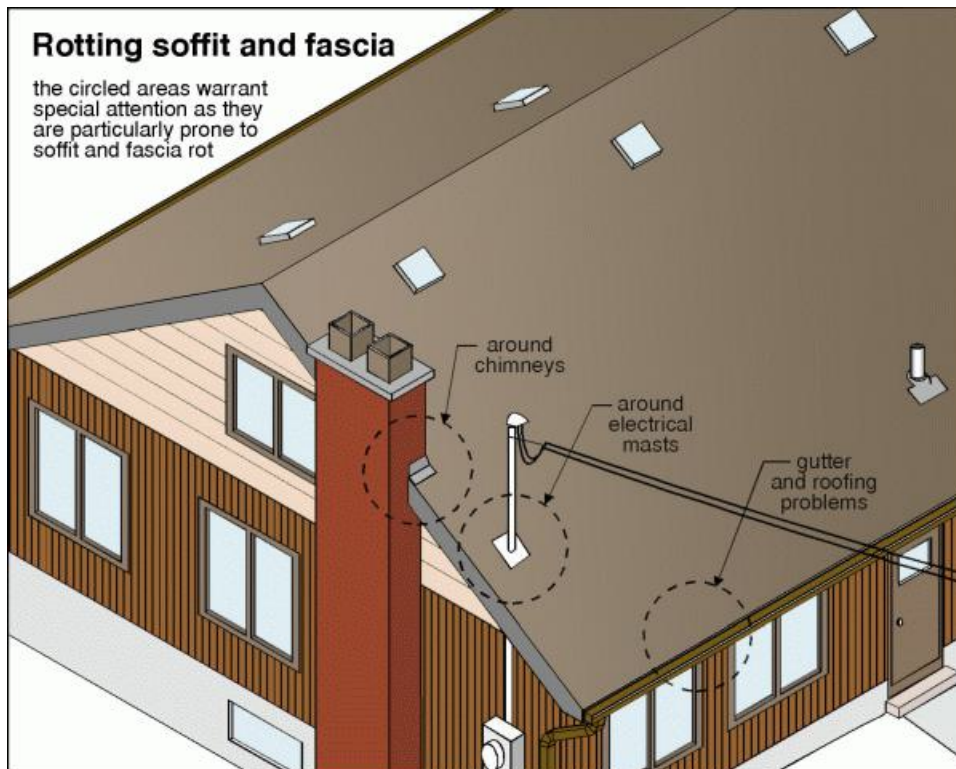
**Condition:** • Observed wood rot or Detected above normal levels of moisture with damage to wood material or noted damage/wood rot/insect damage noted in various locations, Recommend repairing or replacing water moisture damage or wood rot sections to prevent further water intrusion.

**Implication(s):** Chance of water damage to structure, finishes and contents | Material deterioration

**Task:** Handyman Skill Level - Repair or replace as required

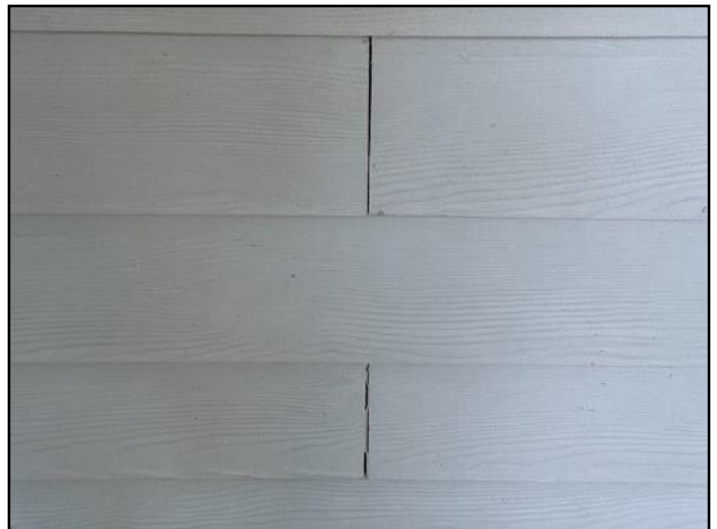
**Condition:** • Marginal

10. Marginal

Recommend caulking at all seams and penetrations around doors and windows to prevent water intrusion

**Task:** DIY Skill Level - Handyman Skill Level - Repair Protect

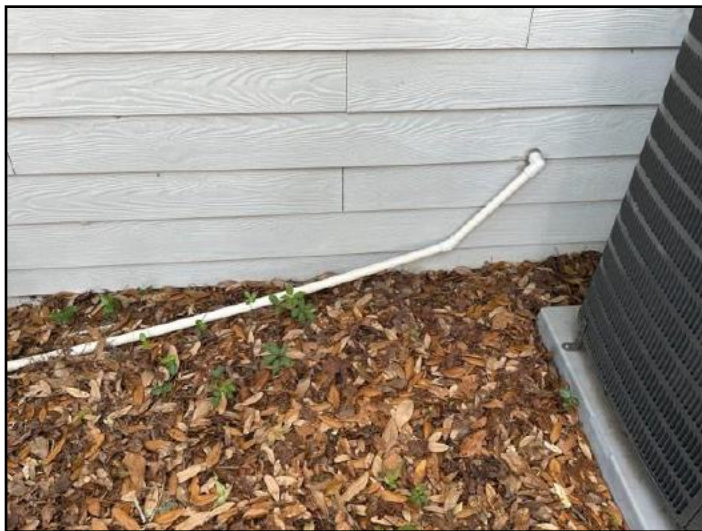
**Condition:** • [Too close to grade](#)

**Implication(s):** Chance of water damage to structure, finishes and contents | Material deterioration | Rot | Insect damage

17. Too close to grade

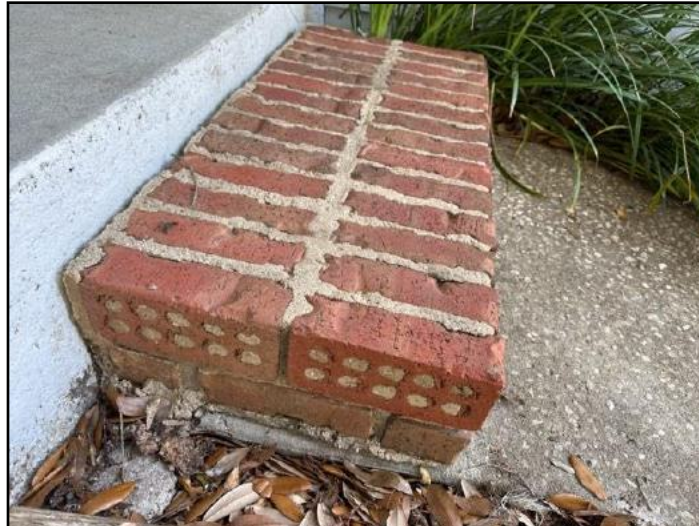
22.

**Condition:** • Noted the front steps are loose. This condition allows them to shift or move.

**Task:** Mason/handyman professional - repair

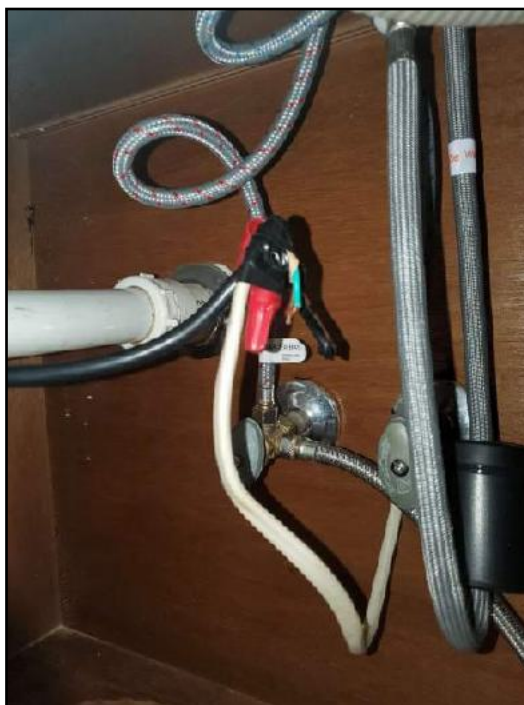
27.

**Condition:** • Improper splice noted for garbage disposal wiring underneath the kitchen sink. Recommend sealing and properly securing in a junction box with an approved cover plate

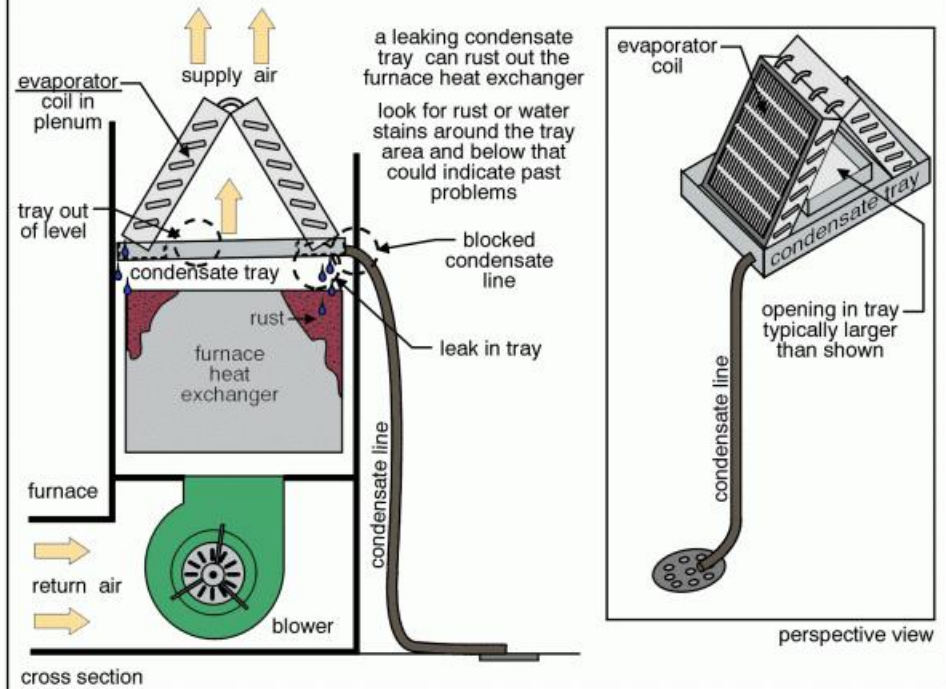
30. Blocked or crimped

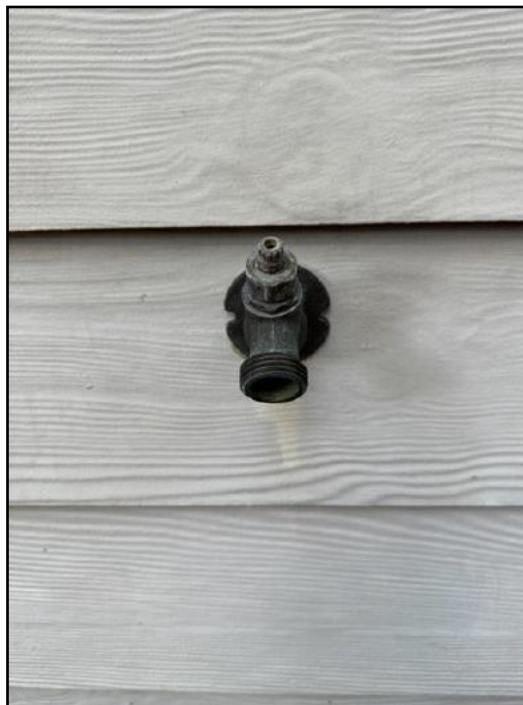
31. Mechanical damage

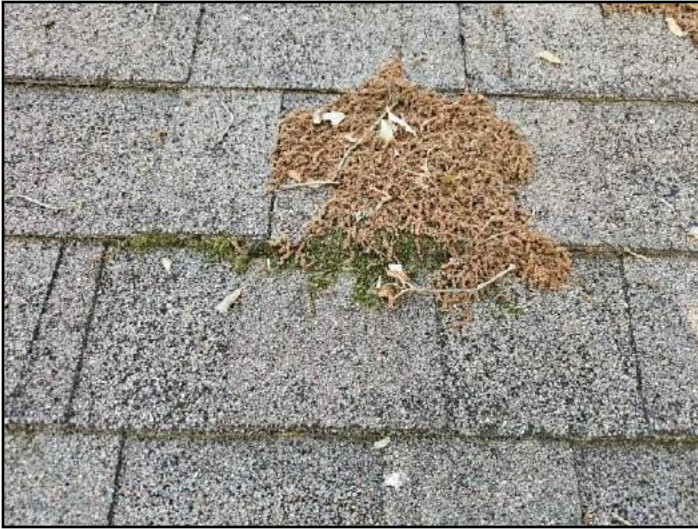
44. Debris/moss

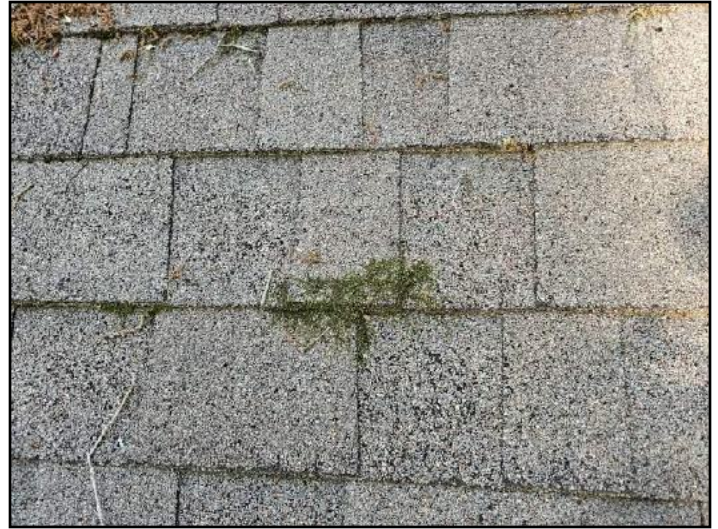
45. Debris/moss

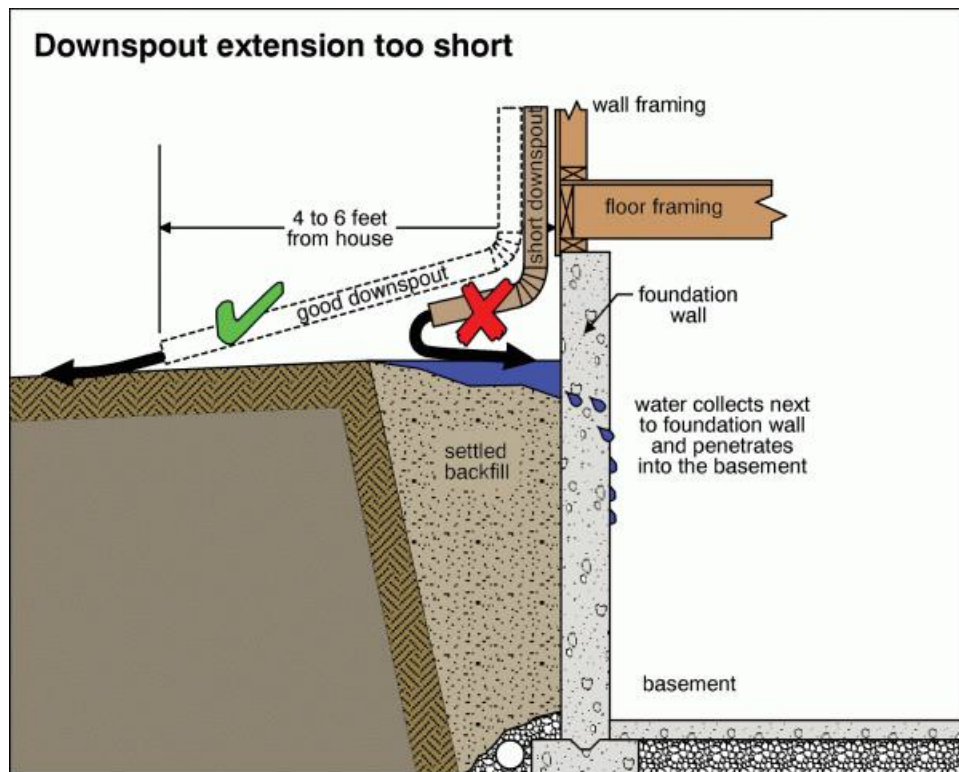
62. Gutter discharge 4-6 feet from building or...

**9. Condition:** • Gutter discharge 4-6 feet from building or foundation can greatly reduce the chance of water collection at the foundation and opportunities for settlement

Gutter downspout extensions can greatly reduce water collection and intrusion into the Crawlspace which can reduce mold and mildew growth. For foundation structures; can reduce the likelihood of soil erosion at the foundation and settlement cracks

**Time:** As soon as practical

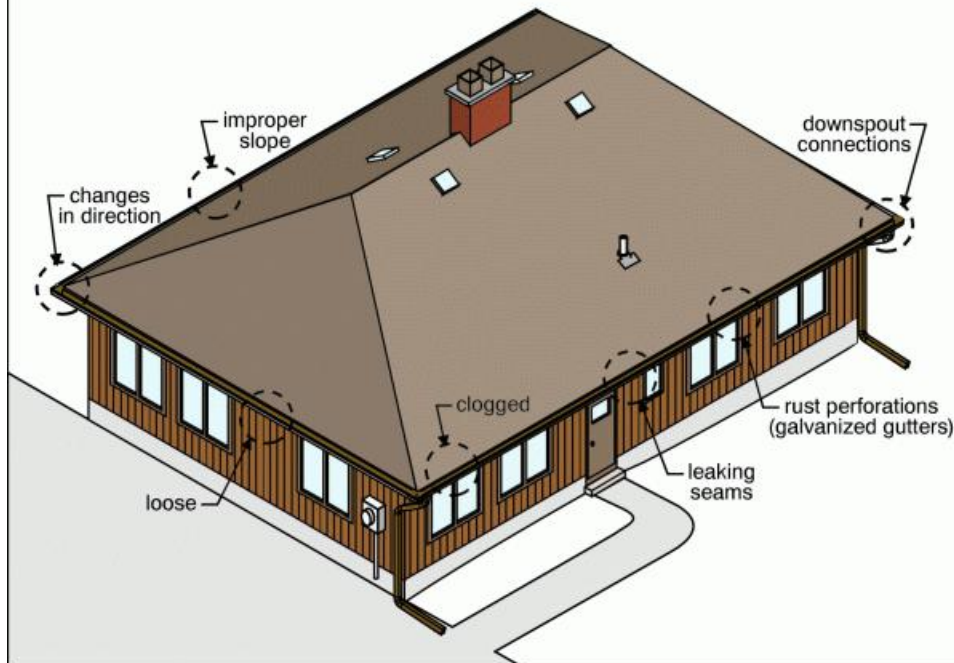
64. Leak

**11. Condition:** • [Leak](#)

**Implication(s):** Chance of water damage to structure, finishes and contents

**Task:** Gutter contractor - repair/replace

**Time:** As soon as practical

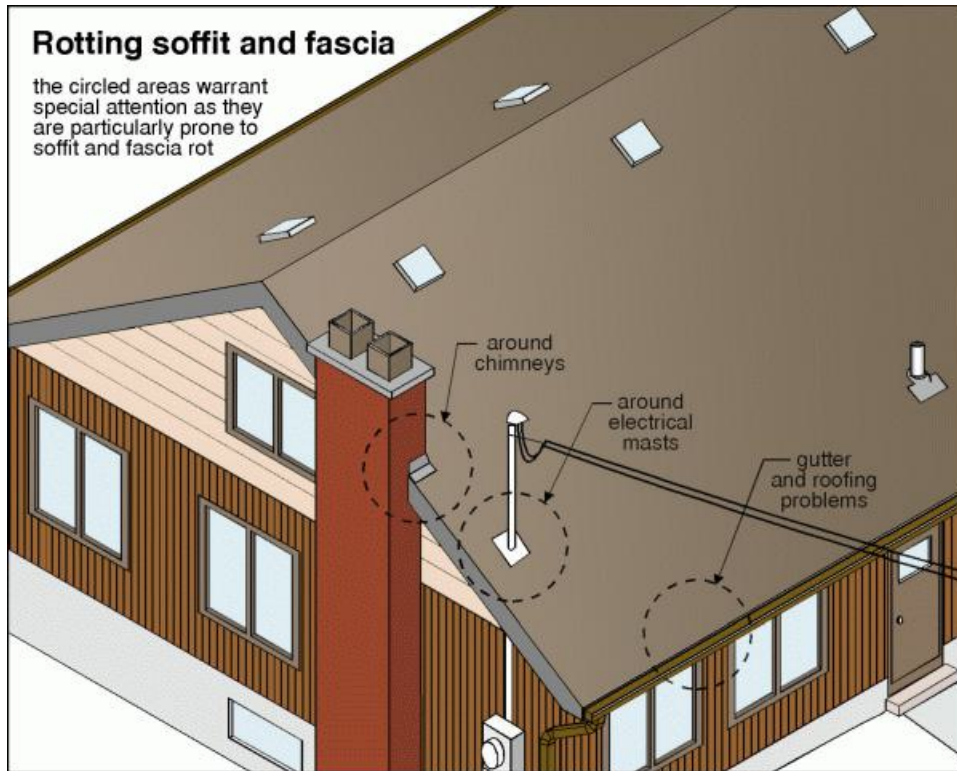
65. Observed wood rot or Detected above normal...

**12. Condition:** • Observed wood rot or Detected above normal levels of moisture with damage to wood material or noted damage/wood rot/insect damage noted in various locations, Recommend repairing or replacing water moisture damage or wood rot sections to prevent further water intrusion.

**Implication(s):** Chance of water damage to structure, finishes and contents | Material deterioration

**Task:** Handyman Skill Level - Repair or replace as required

**Time:** As soon as practical - To prevent water intrusion

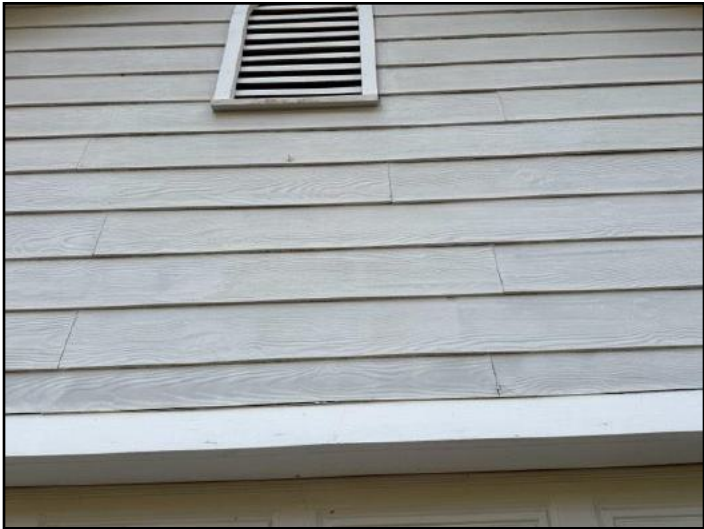
66. Marginal

14. **Condition:** • Marginal

Recommend caulking at all seams and penetrations around doors and windows to prevent water intrusion

**Task:** DIY Skill Level - Handyman Skill Level - Repair Protect

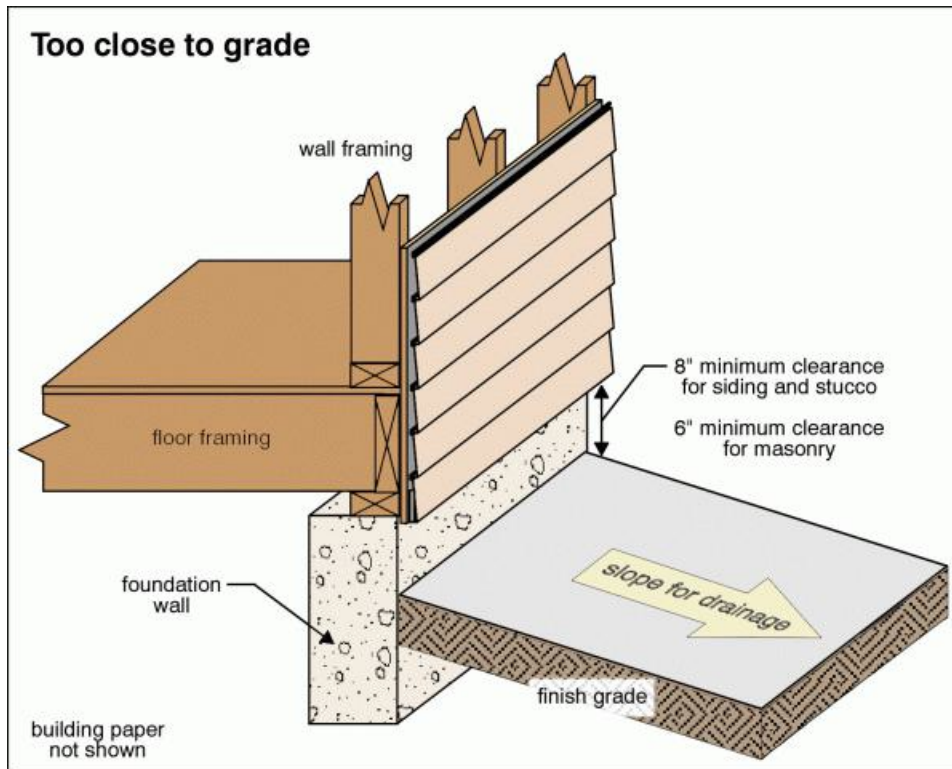
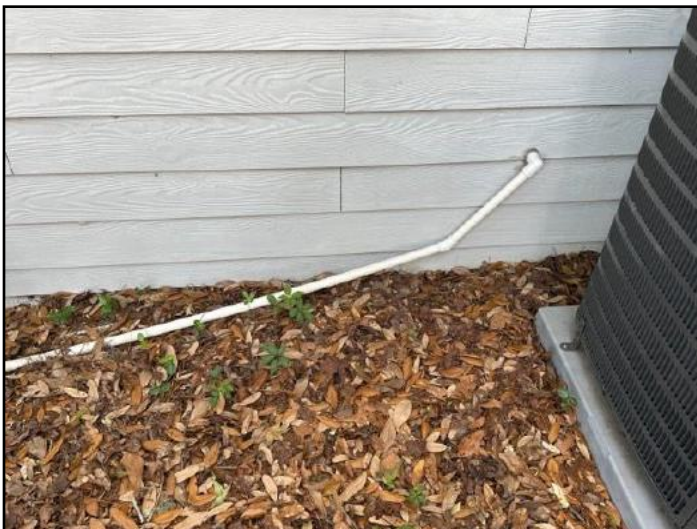
74. Too close to grade

15. Condition: • [Too close to grade](#)

Implication(s): Chance of water damage to structure, finishes and contents | Material deterioration | Rot | Insect damage

Time: Next Annual Maintenance

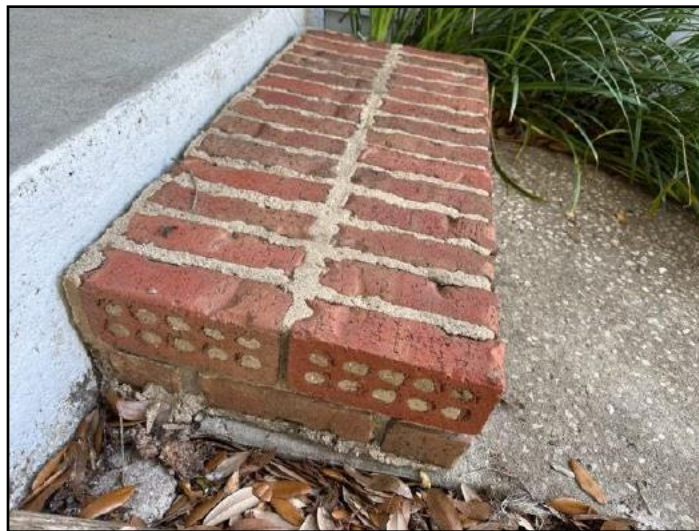
82.

**23. Condition:** • Noted the front steps are loose. This condition allows them to shift or move.

**Task:** Mason/handyman professional - repair

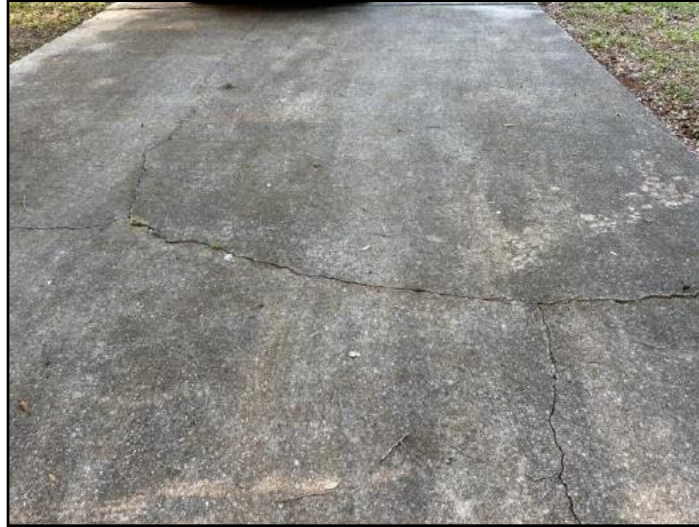
**26. Condition:** • Driveway had some typical cracks and is in satisfactory condition. Recommend to seal all penetrations to prevent water expansion during freeze events and further cracking

**83.** Driveway had some typical cracks and is in...

**Task:** Handyman Skill Level - Seal & Monitor

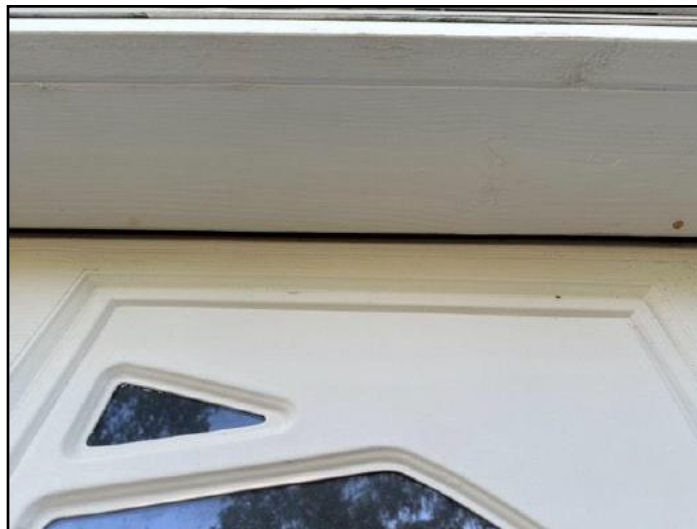
87. Weatherstripping damaged or missing.

**30. Condition:** • Weatherstripping damaged or missing.

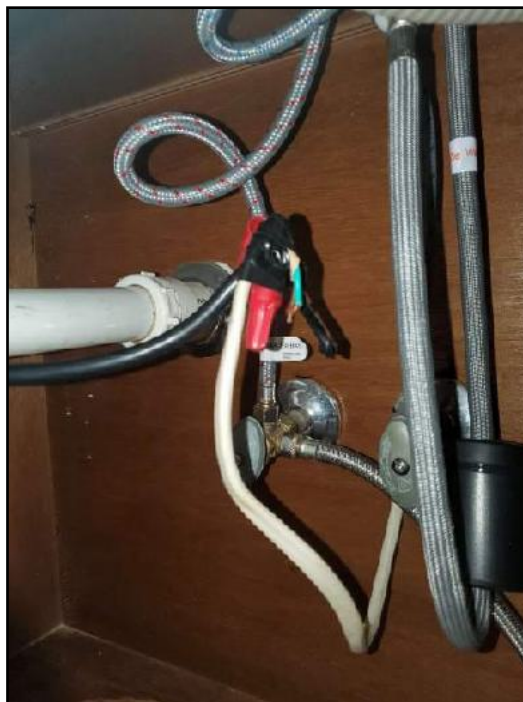
98.

**37. Condition:** • Improper splice noted for garbage disposal wiring underneath the kitchen sink. Recommend sealing and properly securing in a junction box with an approved cover plate

**Task:** Handyman/Electrician - Repair/Protect

**Time:** As soon as possible

**Cost:** Less than \$100 per location - Depends on approach

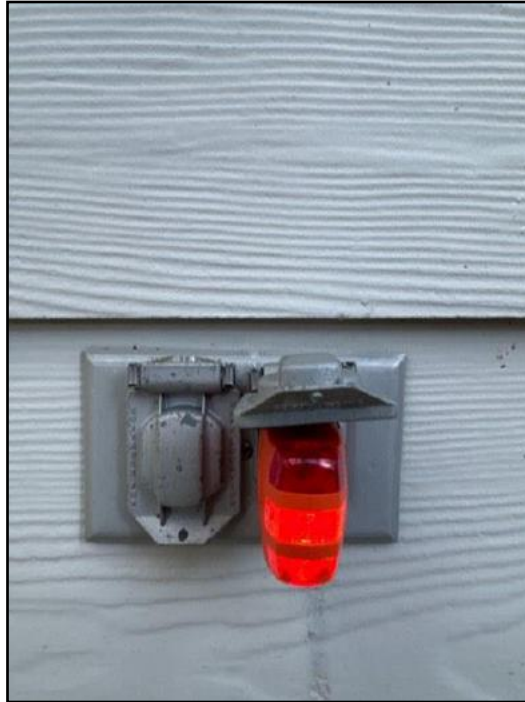
100. Rear patio receptacle Outlet

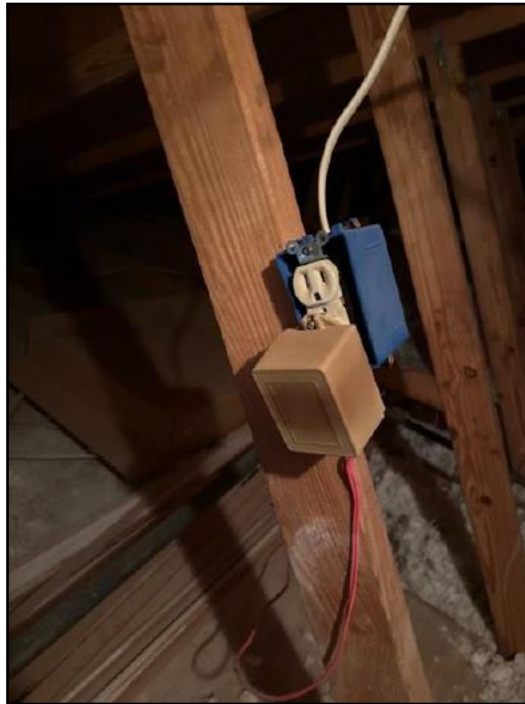
42. Condition: • [Missing](#)

101. Missing

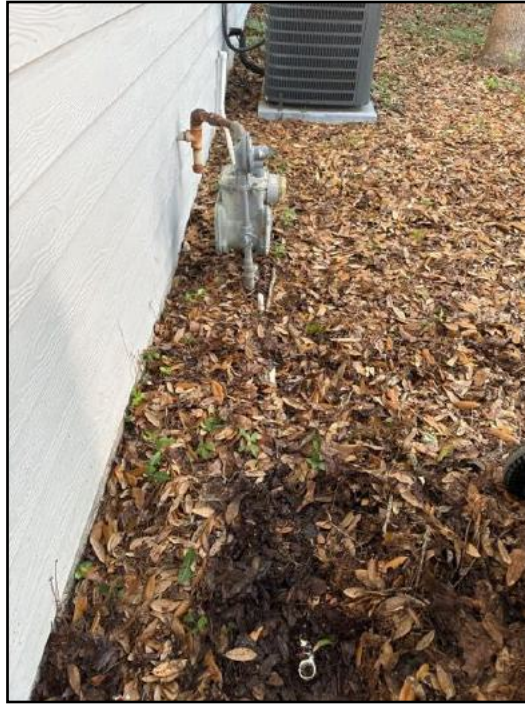
108. Discharges to exterior

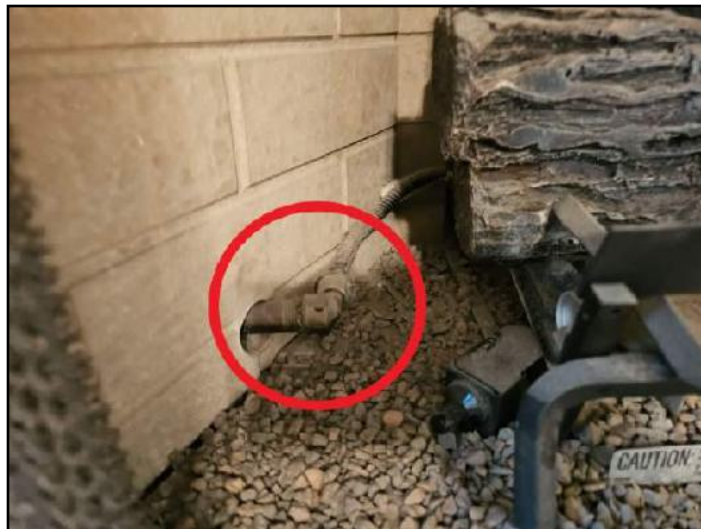
111.

**51. Condition:** • The gas fireplace is not equipped with a inline gas shut off valve or a wall mounted shut off valve.  
Possible safety hazard

**Task:** Plumber or Fireplace Repair Professional

**Time:** As soon as possible

**Cost:** Depends on work needed

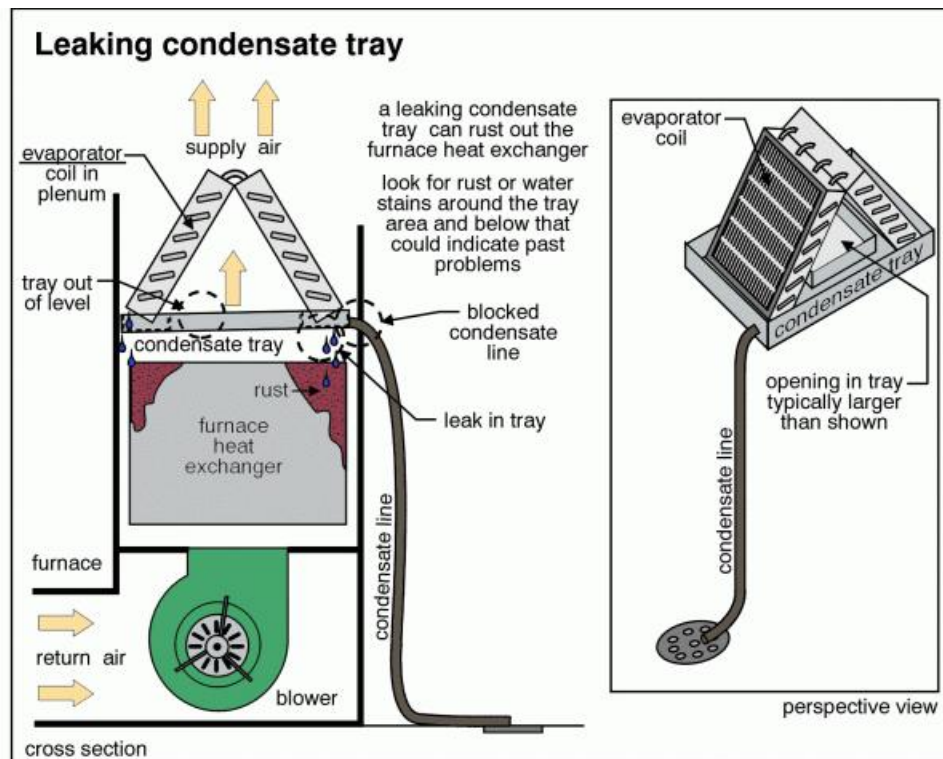
**60. Condition:** • [Blocked or crimped](#)

**Implication(s):** Chance of water damage to structure, finishes and contents | Damage to equipment

118. Blocked or crimped

**Time:** Next Annual Maintenance

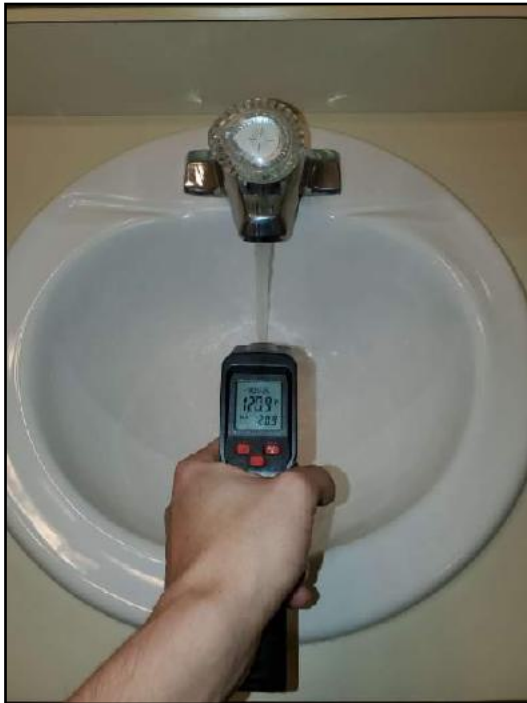
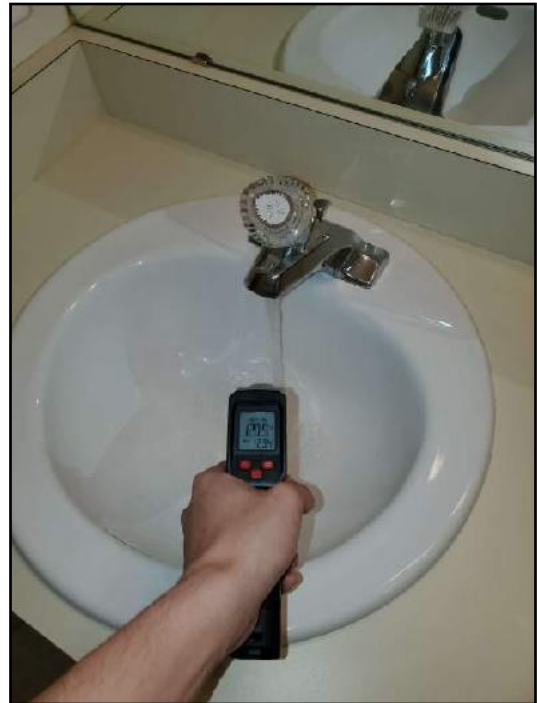
138. 120° F

139. 120° F

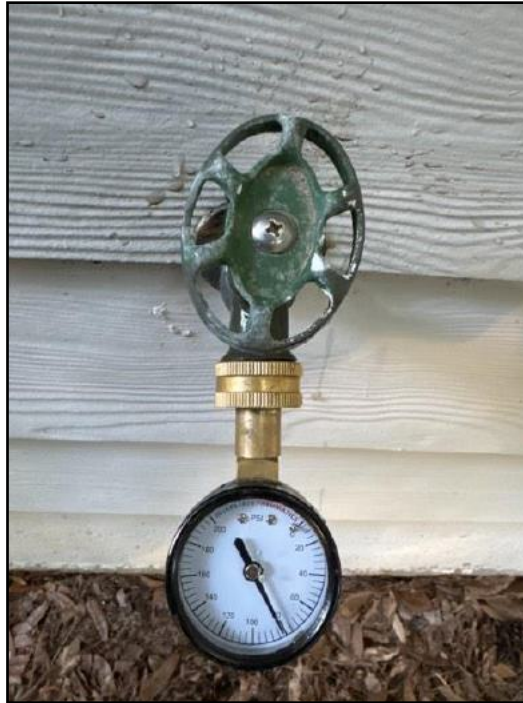
**145. Satisfactory**

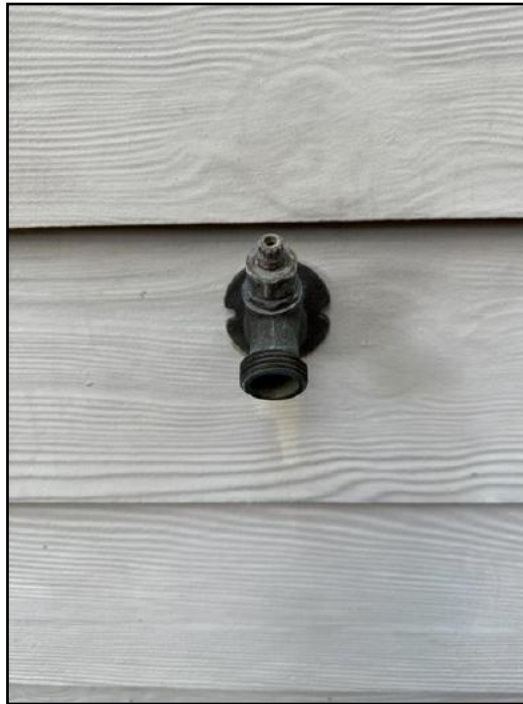
146. Mechanical damage

**70. Condition:** • [Mechanical damage](#)

**Implication(s):** Chance of water damage to structure, finishes and contents | Leakage | System inoperative | No water

**Task:** Plumber - Handyman Professional - Repair or replace

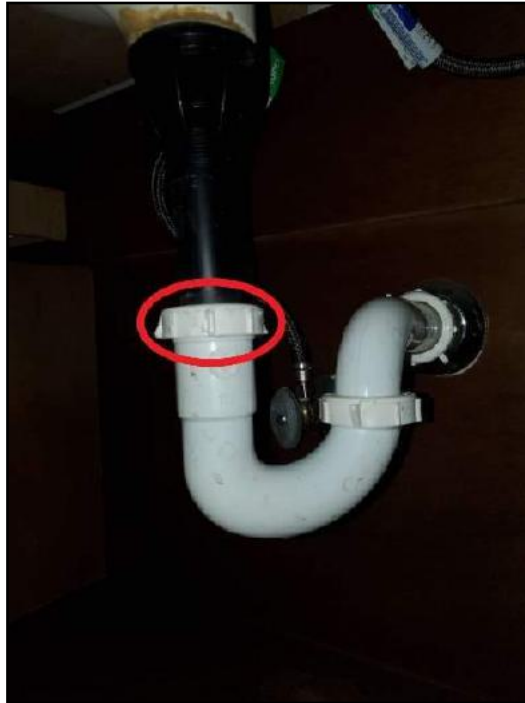
147.

**75. Condition:** • Leaking noted - recommend repair by a qualified professional

**Task:** Handyman/Plumber - Repair

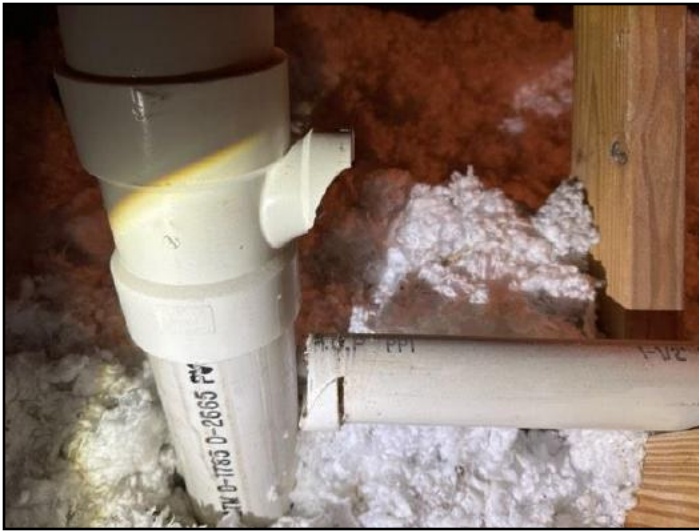
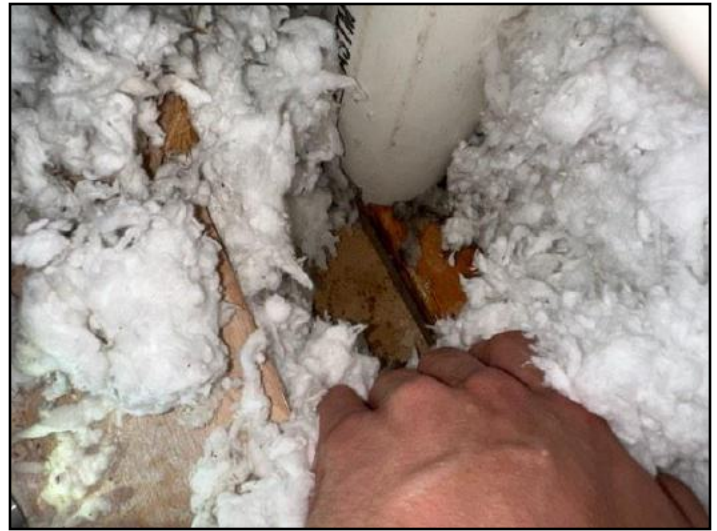
**76. Condition:** • Noted the plumbing vent piping is broken in the attic. This condition is allowing water to leak in the attic. The vent pipe having water present could indicate a possible clogged drain condition.

**Task:** Plumber - Correct

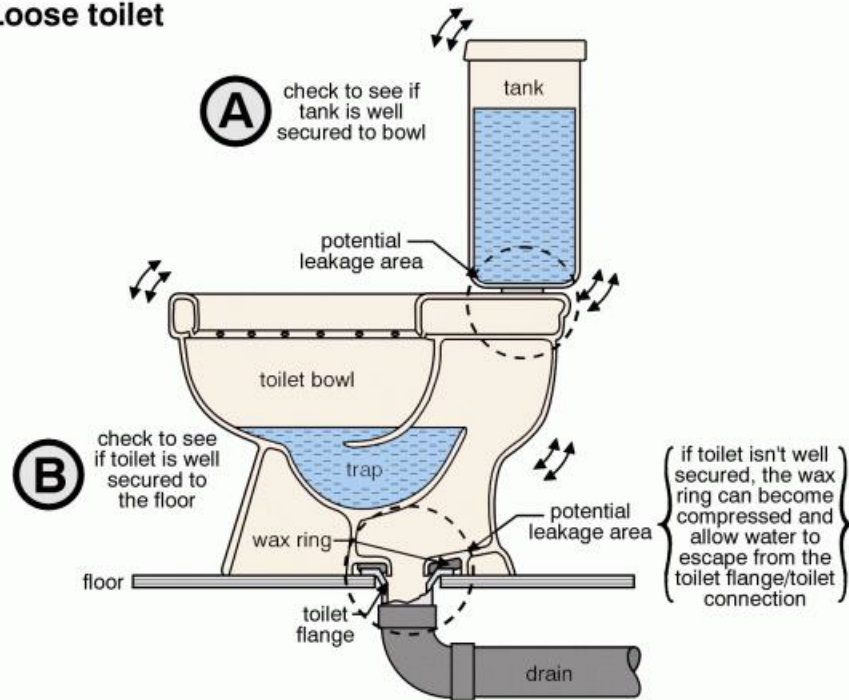
## Loose toilet

**79. Condition:** • The toilet in the bathroom is loosely attached at the connection of the bowl to the floor. This can allow leaks at or into the floor. We recommend removing the toilet, checking the floor flange, replacing the wax ring, and re-setting the toilet. The base of the toilet should be caulked around the perimeter at the oor to prevent slippage and damage to the wax ring that seals the toilet to the drain pipe.

**Implication(s):** Chance of water damage to structure, finishes and contents | Sewage entering the building | Possible hidden damage

**Task:** Handyman Skill Level - Repair

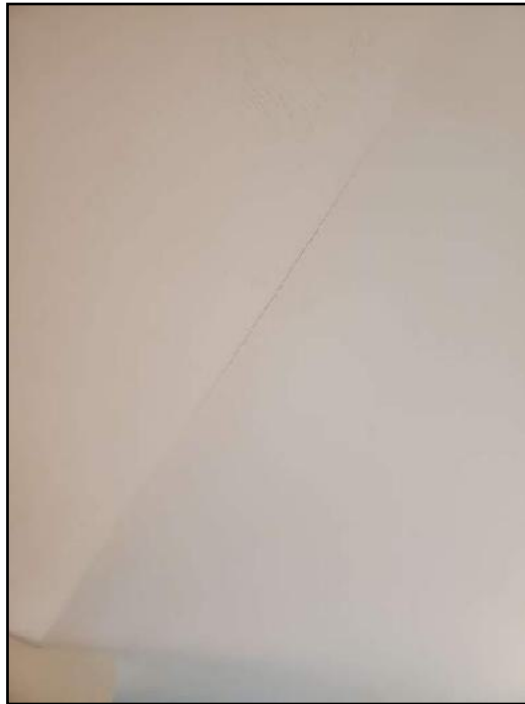
90. Condition: • Ceiling and walls constructed of sheetrock. Noted only typical cracks and sheetrock finishing. There is no noticeable vertical displacement or evidence of significant settlement. Expansion and contraction of the home during different times of the year can create typical cracks between seam ends around corners. The crack appears to be typical for this type of construction. Cracks should be sealed to prevent further issues. If cracking appears to worsen, then a structural professional should evaluate.

161. Ceiling and walls constructed of sheetrock....

**Task:** DIY/Handyman Skill Level - Repair/Seal

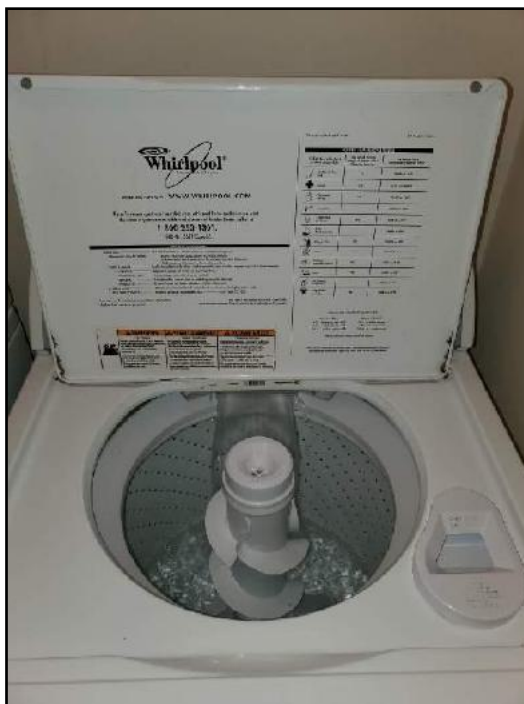
170.

**106. Condition:** • While the washing machine appears to be operational during the time of inspection, noted burning smell when testing and the drum would not spin after initial filling. Recommend follow-up with a qualified Appliance Repair professional for further evaluation and repair

**Task:** Appliance Repair Professional - Further evaluation Recommended
